KOKOSING RIVER RESTORATION

A MULTI-PHASE EFFORT TO ADDRESS HABITAT DEGRADATION, RIVER BANK EROSION, AND WATER QUALITY IMPAIRMENT ALONG OUR KOKOSING RIVER

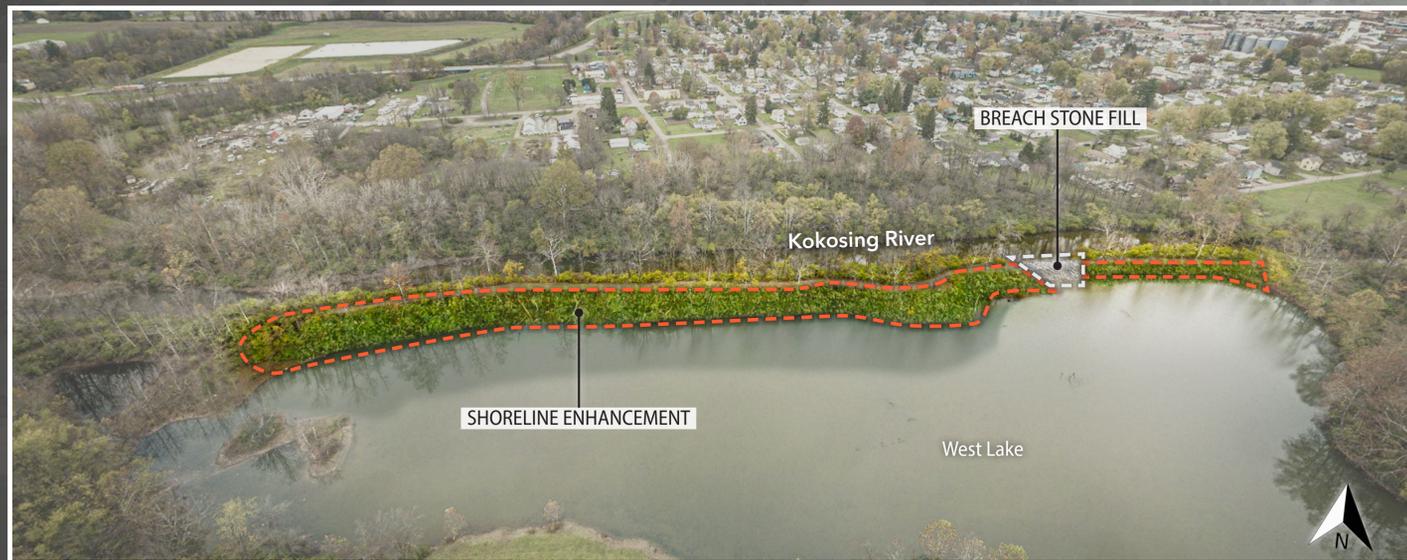
FLOODPLAIN ACCESS AND HABITAT ENHANCEMENT

The project at West Lake repaired a breach in the embankment separating the Kokosing River from this lake, a former mining quarry, caused by a 2017 flood event. The project also lowered the remaining embankment and created a more stable lake shoreline with integrated aquatic habitat features. The lowered embankment improves floodplain access for the river and broadens the riparian corridor separating the river and the lake, while also improving access to the lake for enjoyment by park visitors.

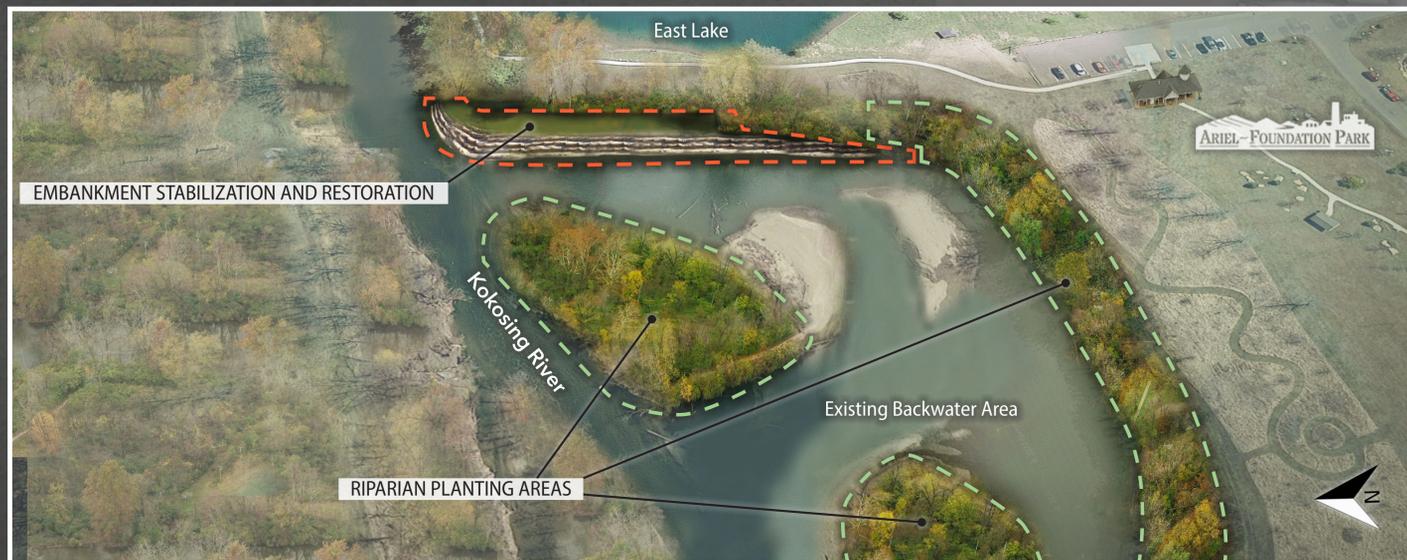
RIVER RESTORATION

The project at Norton Street provided 700 linear feet of embankment stabilization and restoration in a backwater area along the Kokosing River. The purpose of this project was to protect the river from breaching into the East Lake, and protect the unique aquatic habitat features of those two water bodies. The restoration utilized bioengineering techniques, including soil wraps supplemented with planting of native vegetation.

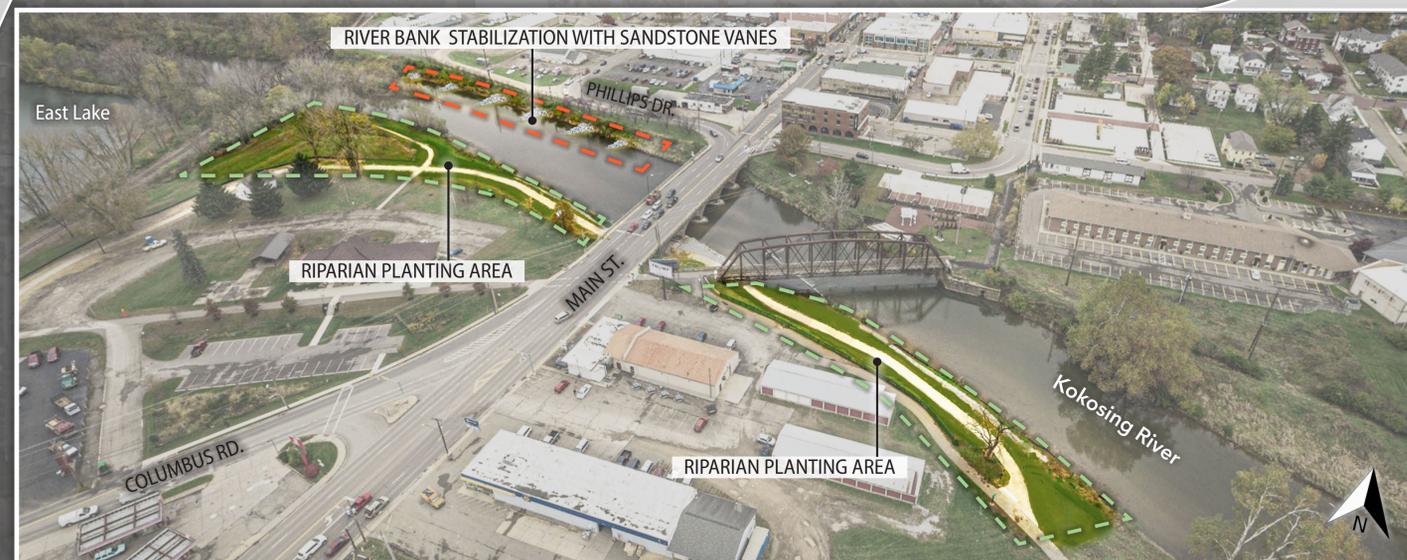
RIVER BANK PROTECTION

The project at Phillips Drive stabilized and protected approximately 800 linear feet of river bank by installing stone and vane arm structures. The vanes are in-channel rock structures placed to redirect flow into the center of the channel, away from the river bank. The project also included enhancement of the riparian corridor by planting approximately two acres with native trees and shrubs.
